**SECURE DOCUMENT STORAGE FACILITY
BAGHDAD, IRAQ**

SUSTAINMENT ASSESSMENT

**SIGIR PA-08-166
OCTOBER 20, 2009**

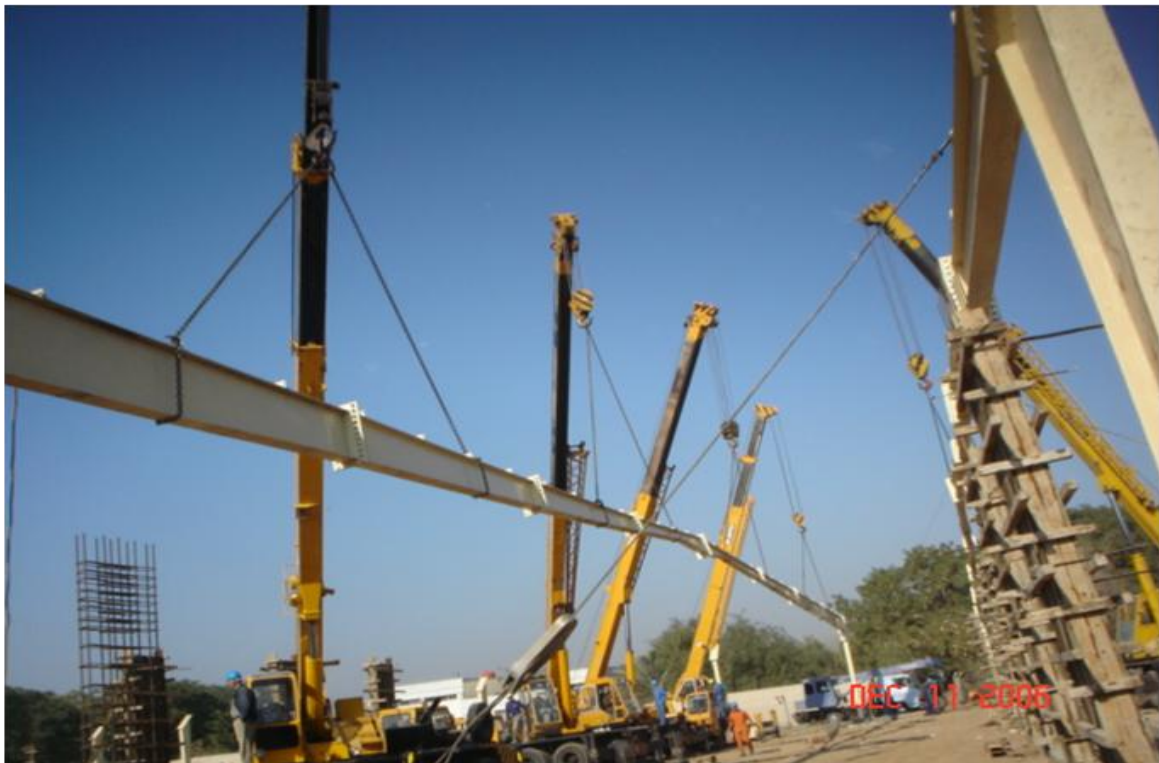
Site Photo 1. Initial construction of the steel columns prior to the structural failure (Courtesy of GRC)

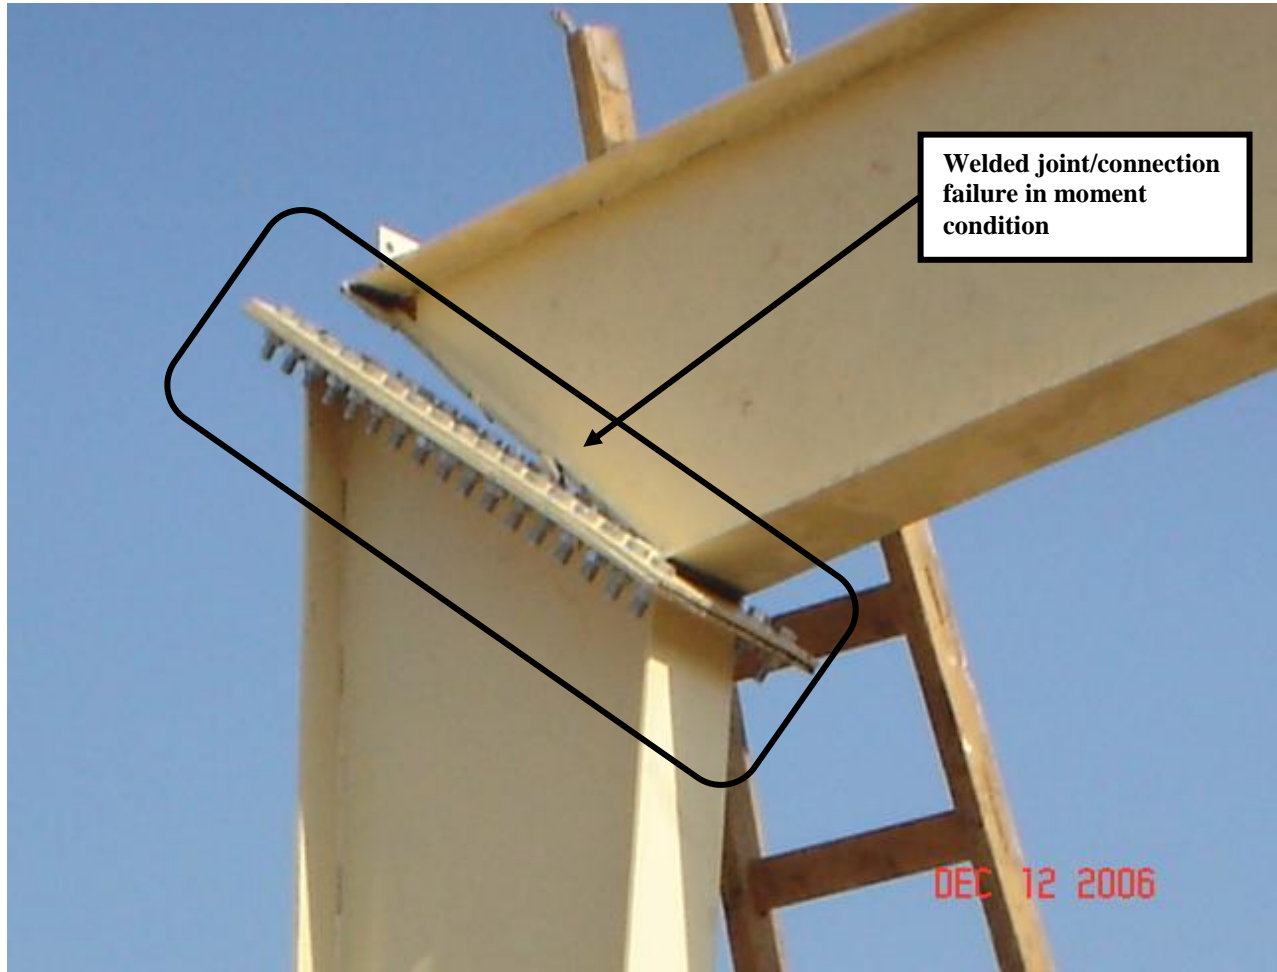
According to project file documentation, the contractor started work on 10 August 2006. At the beginning of the project, the contractor appeared to make steady progress. However, upon reviewing the project file photographs for the installation of steel columns, SIGIR immediately noticed that the contractor's beam span was far too long (Site Photo 1). SIGIR's concern was confirmed when the contractor initially placed the roof members and a structural failure occurred (Site Photo 2).

Site Photo 2. Structural failure resulting from contractor's inadequate initial design (Courtesy of GRC)

SIGIR reviewed the contractor's initial design. It appeared that the contractor failed to coordinate the design information with the drawings released for construction, which resulted in at least two significant omissions contributing to the initial failure of the structure and the subsequent need for reinforcing:

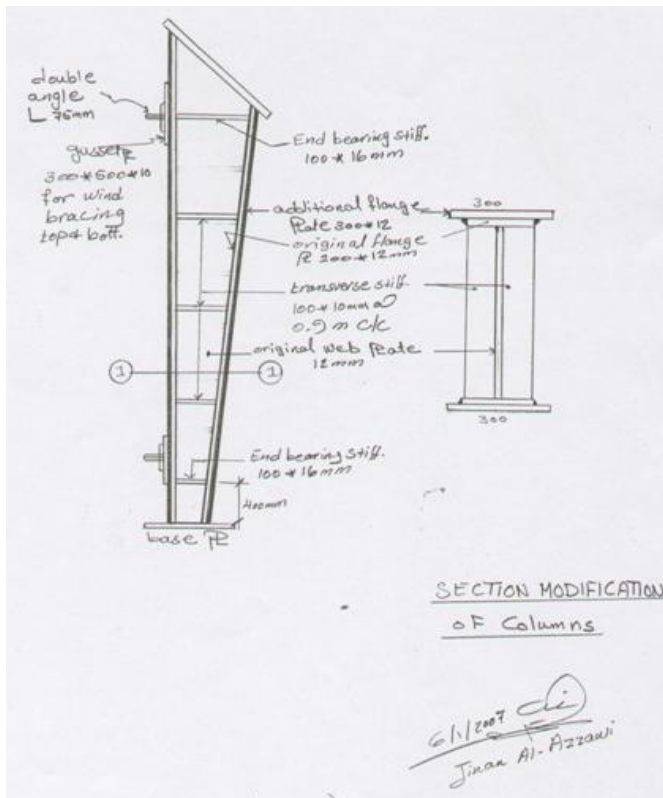
Figure 1. Strengthening columns

After the December 2006 structural failure, the contractor performed an evaluation and proposed a revised design in January 2007. Specifically, the contractor proposed reinforcing the structure to accommodate the design deficiencies. The proposed solution consisted of the following:

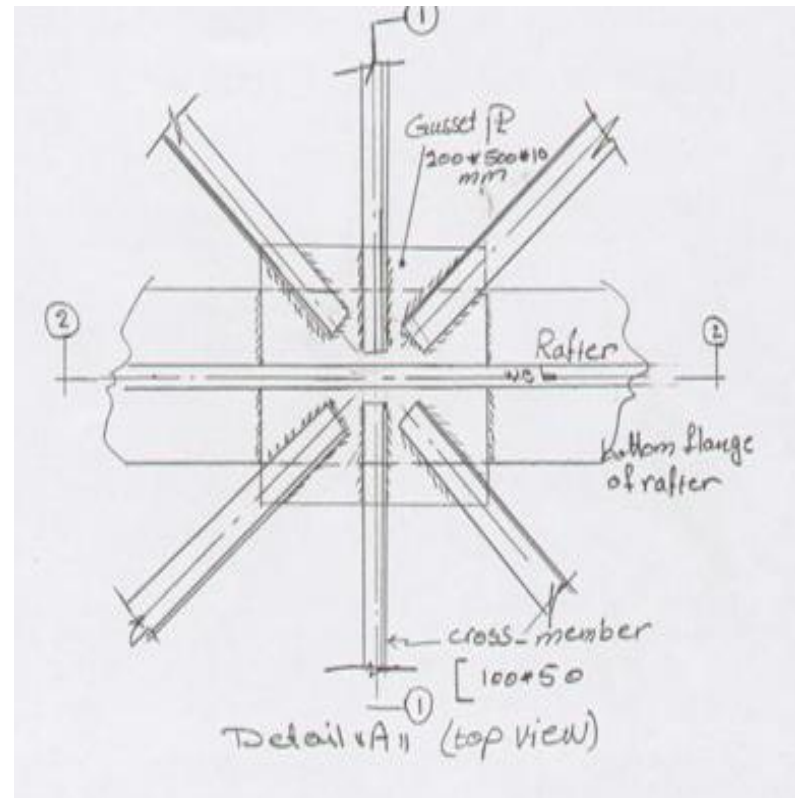
Figure 2. Additional bracing

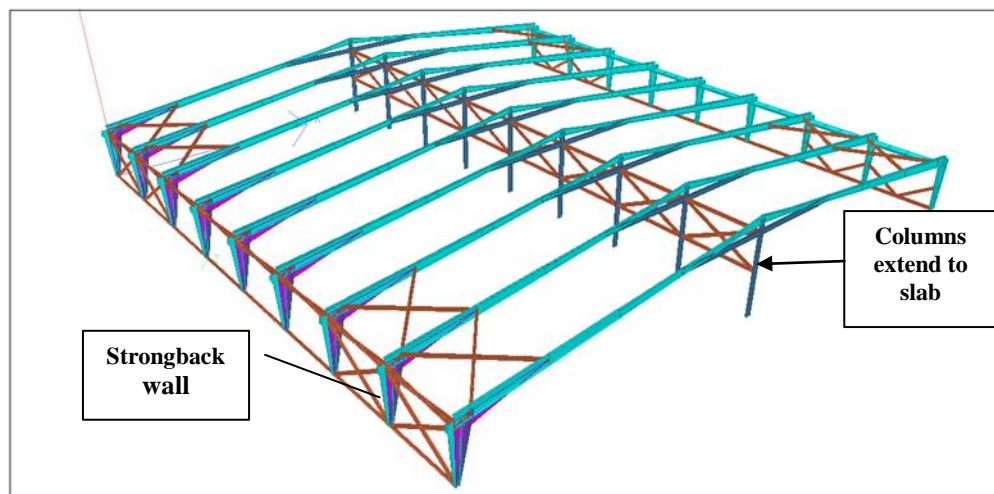
Figure 3. Three-dimensional model of contractor-proposed improvements (Courtesy of GRC)

Figure 3 illustrates the proposed new steel columns along the centerline, extending to the floor. However, by this time, the interior vault rooms had already been constructed, including a reinforced-concrete beam and partition wall running the length of the building, beneath the centerline of the steel frames. Based upon review of the October 2007 QA reports, it appeared that the contractor performed a modified approach to placing the columns. A base plate was placed on the top of the reinforced-concrete beam, and the columns were welded to the base plate (Site Photo 3). Consequently, this model and corresponding structural analysis do not account for the additional load to the reinforced-concrete beam, supporting columns, and foundation.

The contractor provided a revised design submittal in January 2007 to correct the design deficiencies that led to the structural failure. In July 2007, the GRC quality assurance (QA) representative documented examples of the building not being constructed in accordance with the planned structural improvements of January 2007. On 26 July 2007, a GRC structural engineer performed an inspection of the construction to date. The GRC structural engineer issued an observation report, which identified several construction deficiencies; all structural work again stopped while the contractor performed another structural evaluation. In September 2007, the contractor presented GRC with structural improvements, including a structural analysis indicating that the proposed improvements would provide a stable structure under eight different loading conditions. The proposal included a row of columns to be constructed along the centerline of the facility, as well as other strengthening improvements, such as corner bracing, cross bracing, and a strongback¹³ wall (Figure 3).

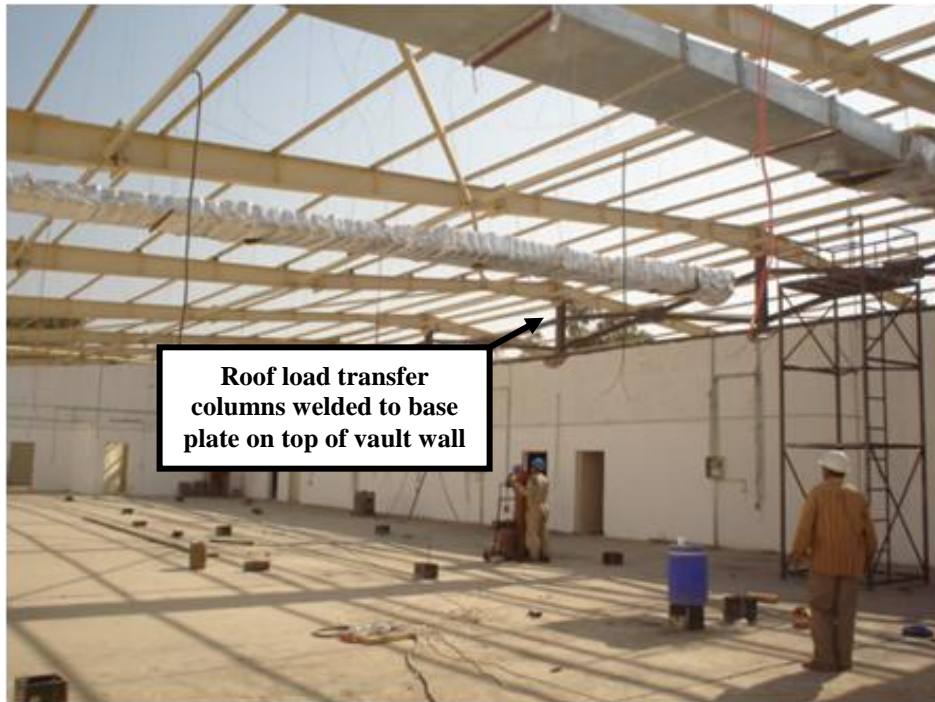
Site Photo 3. Base plate and columns (Courtesy of GRC)

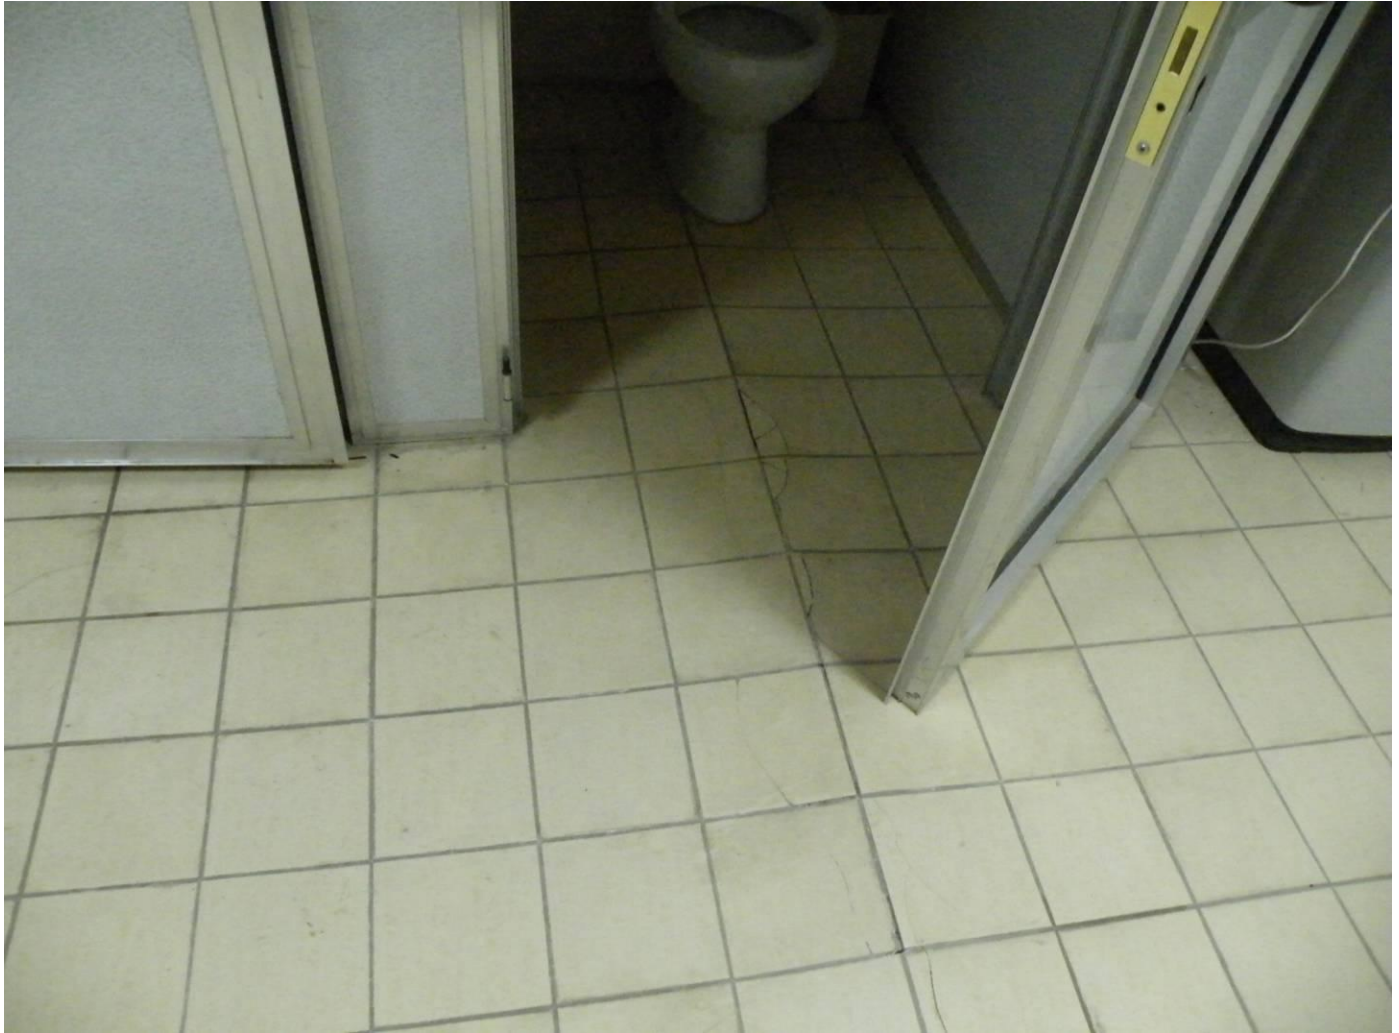
The SOW required the construction of four masonry wall 4.6m x 4.6m latrines—two male and two female (one eastern-style and one western-style toilet in each latrine). SIGIR visited all four latrines. SIGIR identified low-quality (not durable) sink fixtures leaking in two of the latrines. In addition, SIGIR noticed that the tile floors were either cracked or buckled due to poor installation (Site Photo 8). The SDSF facility manager stated that the hot water heater in one of the male latrines consistently burned out, even after the IHT replaced it. SIGIR inspected the hot water heater but could not determine if the problem was inferior hot water heaters or a more serious wiring issue.

Site Photo 8. Example of tile cracking and buckling inside SDSF latrine

1. Repair the floor in all four bathrooms.
2. Repair the HVAC duct insulation and reconnect the flex duct to the registers.

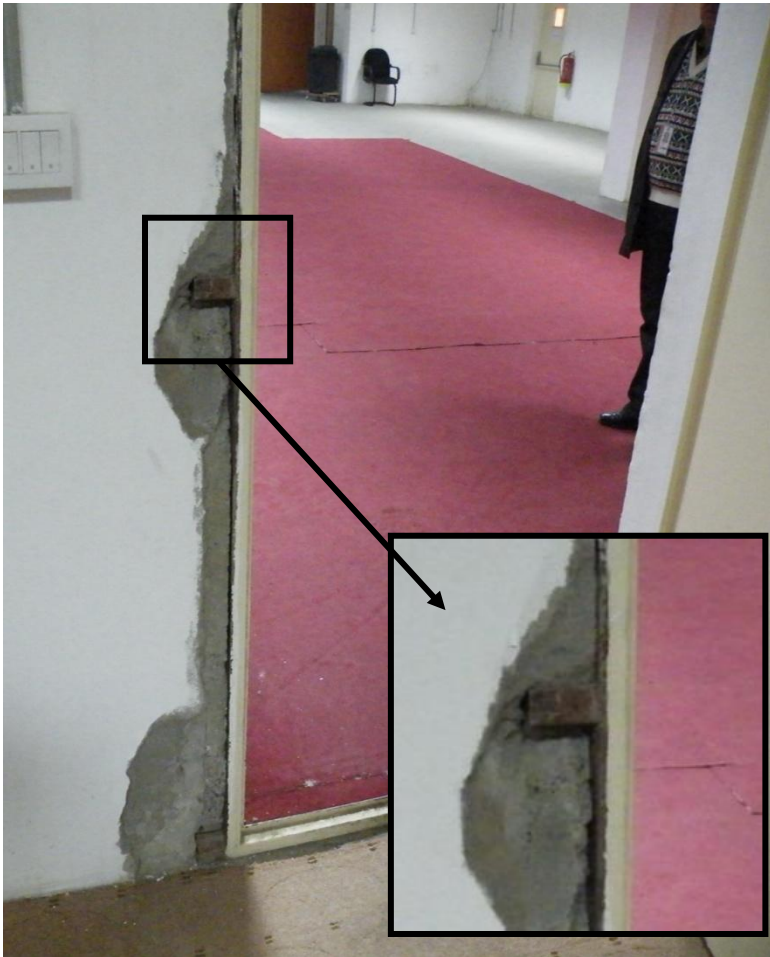
Throughout the SDSF, SIGIR observed significant damage to the interior and exterior door frames (Site Photo 9). According to the SDSF facility manager, the original doors used were too heavy and the door assembly fell out of the wall, which caused damage to the surrounding walls. The SDSF facility manager stated that IHT maintenance personnel were able to reattach the door, but at the time of the site visit, the surrounding walls had not been repaired.

SIGIR did observe damage to both interior and exterior door frames. Site Photo 9 shows a poorly installed door frame. The frame anchor is not embedded into the concrete block wall securely; instead, it is outside the block wall, which left the door frame being secured by the plaster covering the block wall. The door frame is too heavy for the plaster and eventually cracked the plaster and fell off. The SDSF facility manager stated that IHT maintenance personnel had reattached several door frames throughout the facility; therefore, SIGIR could not assess the quality of the contractor’s door frame installation. (The door frames that did not fall off were still covered with plaster; the door frames that did fall off had been reattached by IHT maintenance personnel.)

Site Photo 9. Interior door damage

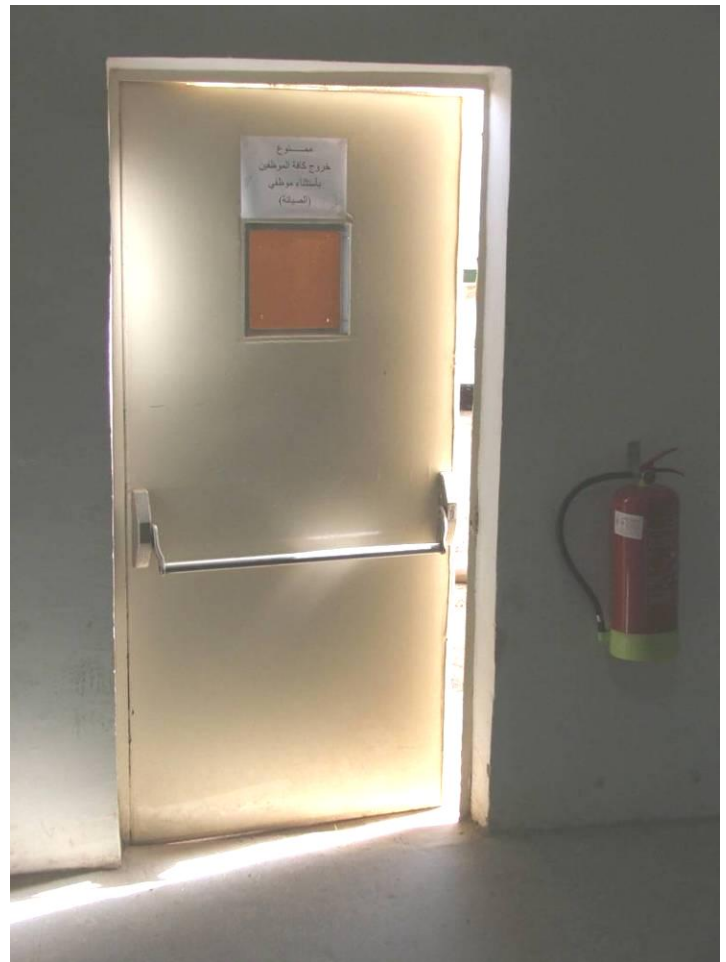
Site Photo 10. Door unable to fully swing open

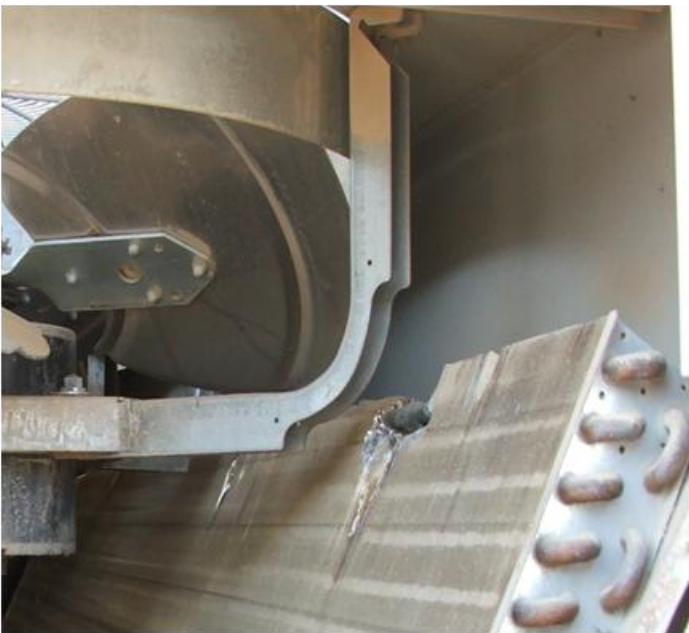
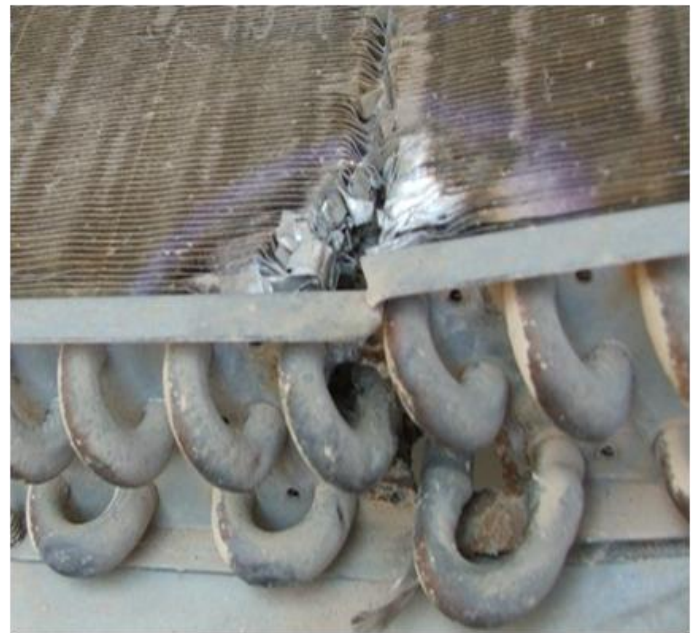
According to the SDSF facility manager, the air-conditioning system has been the most significant issue with the facility. The SDSF facility manager believed that the contractor provided used air conditioners, two of which did not work shortly after the IHT took occupancy of the facility. The SDSF facility manager opened the air-conditioning units and pointed out soldering and welding, which he believed proved that the contractor provided previously used units (Site Photos 11-13). At the time of the first site visit, the SDSF facility manager told SIGIR that all four units did not work. The SDSF facility manager stated that when the air-conditioning units did not work, numerous telephone calls were made to the contractor to correct the units. According to the SDSF facility manager, the contractor never responded. As the intense heat of summer approached, the necessity of operational air-conditioning units became paramount; consequently, IHT maintenance personnel decided to “repair” the units.

GRC representatives visited the SDSF to evaluate the air-conditioning unit issue. Since the IHT acknowledged attempting to repair the air-conditioning units, GRC concluded that the air-conditioning issue was not covered under the contractor’s warranty due to the “tampering, poor maintenance and unskilled personnel working on this equipment.”

Site Photos 11 and 12. Soldering done on HVAC units

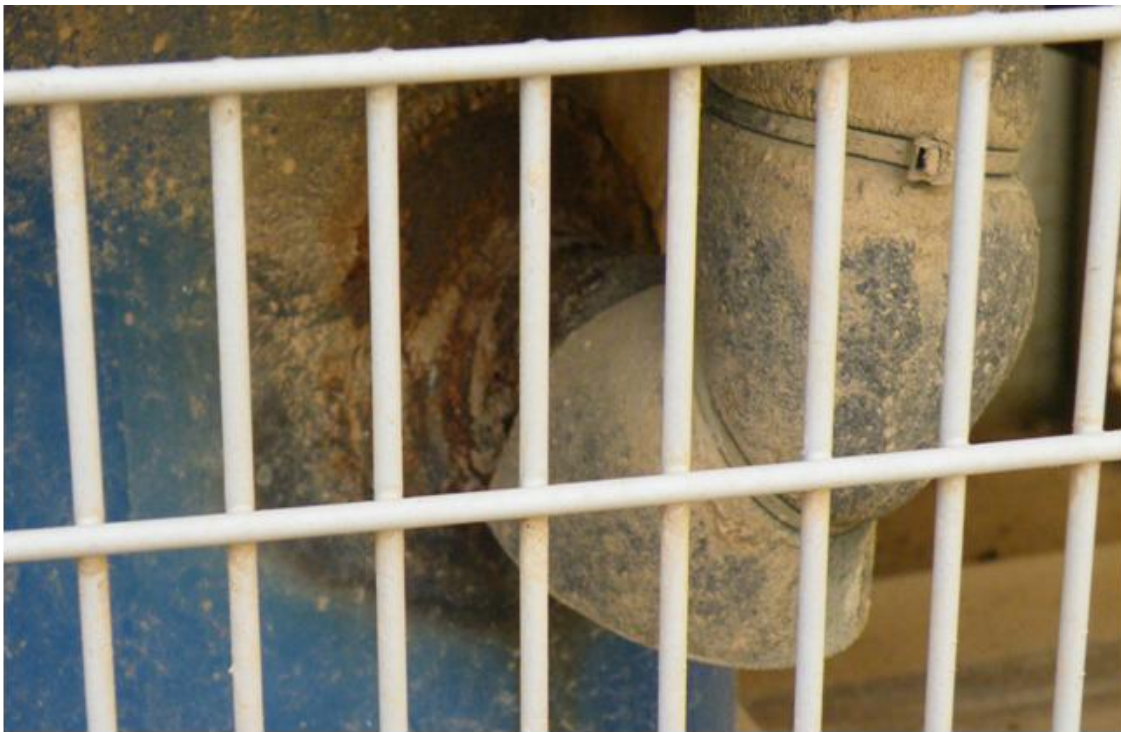
Site Photo 13. Welding done on HVAC unit

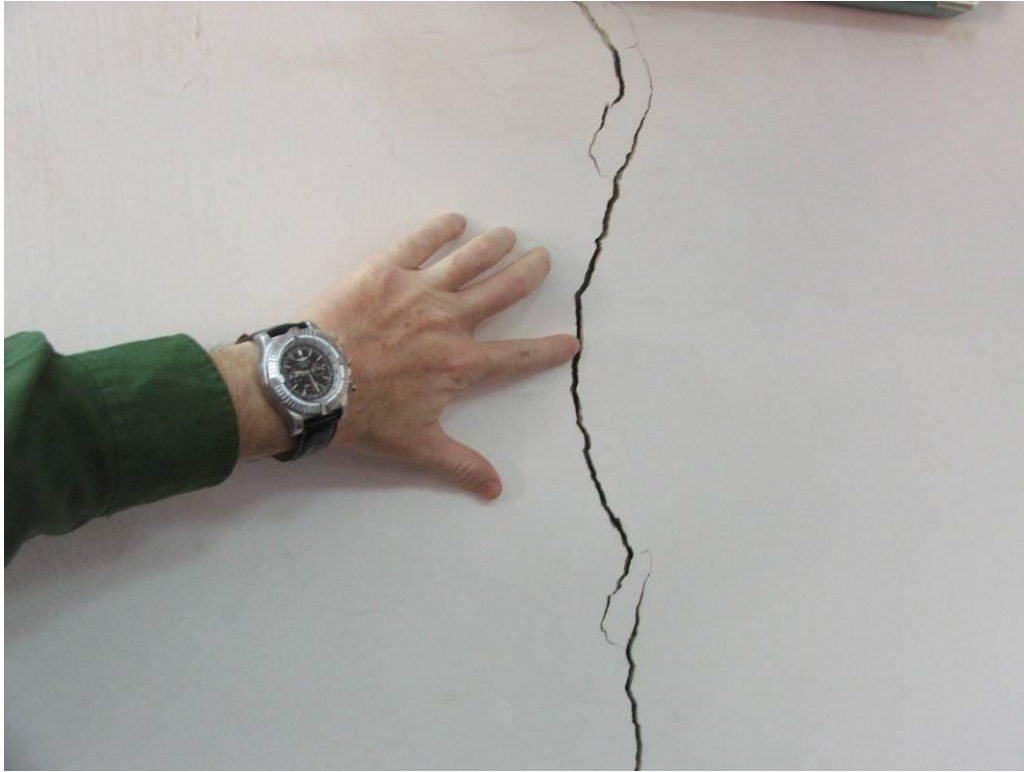
SIGIR observed numerous large cracks to the interior and exterior walls throughout the facility (Site Photo 14). GRC inspected the interior walls and stated that the "cracks in the plaster are caused by expansion and contraction of the plaster. The cracks extend only through the plaster not into the structure." Therefore, GRC did not view the wall cracks as warranty items. However, the cracks are an indication of poor-quality construction; considering that the wall cracks occurred before the facility was even one year old, SIGIR is concerned that these cracks will continue to spread and new cracks will emerge. SIGIR believes that the wall cracks should be addressed under the warranty.

Site Photo 14. Example of cracking of interior wall

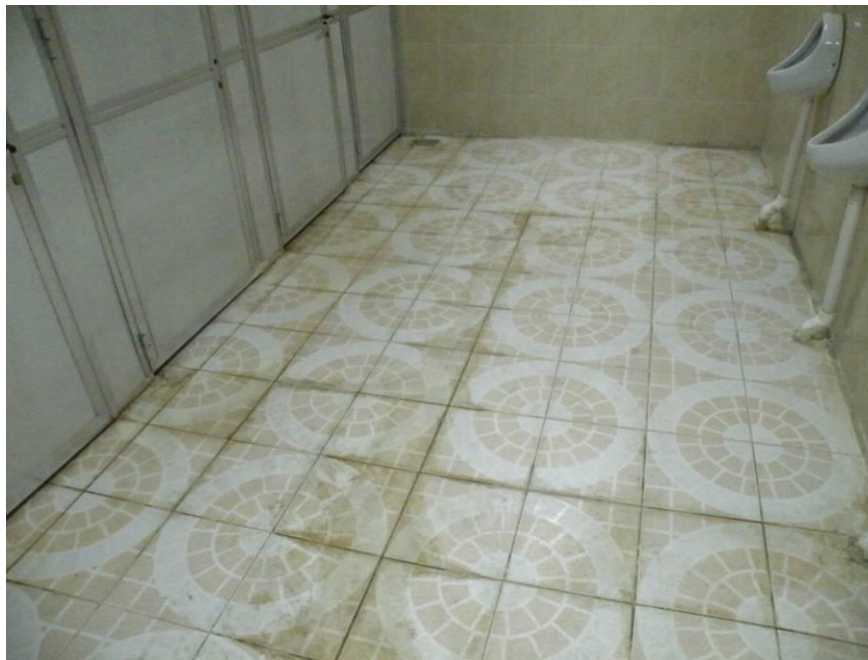
**Site Photo 15. Contractor replaced previously cracked and buckling floor tiles
(See Site Photo 8 for original condition of bathroom floor.)**

However, during the 27 September 2009 site visit, SIGIR toured the entire facility and determined that the contractor had remedied the previously identified warranty deficiencies (Site Photo 15). The SDSF facility manager stated that the GRC IZ Resident Office did an excellent job of requiring the contractor to return to the facility three times to ensure that each warranty issue was adequately addressed.

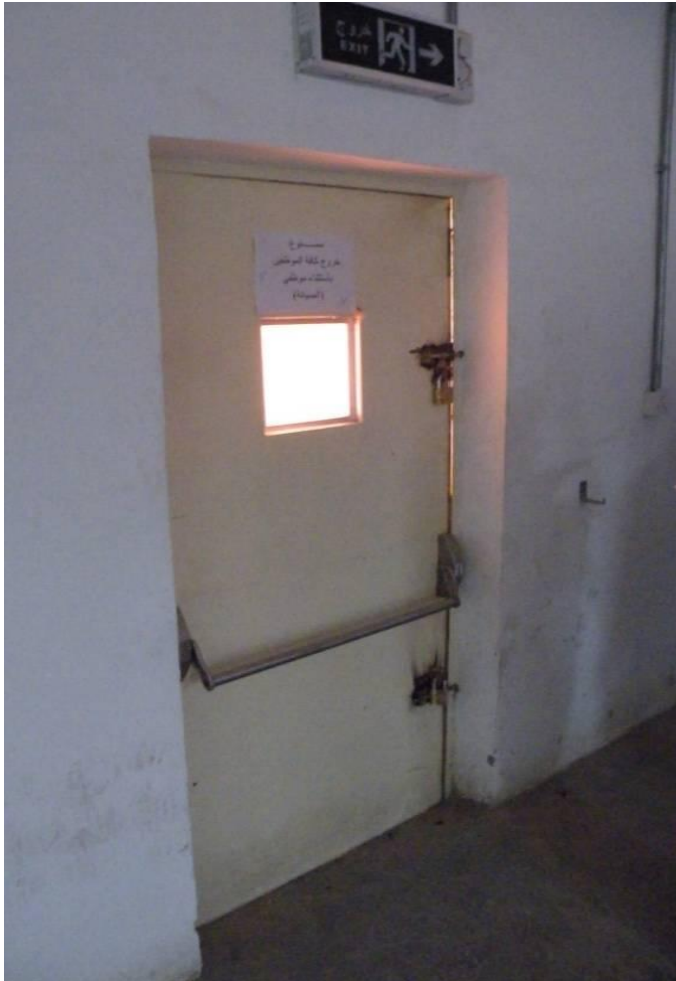
Site Photo 16. Newly installed security door funded by the IHT

In addition, the IHT used its own funding to correct some of the other issues not covered by the warranty, such as the HVAC units and interior/exterior doors. The IHT purchased several condensers, which remedied the HVAC unit problems; purchased a small air-conditioning unit for the room without air vents; and purchased and installed quality security doors and frames (Site Photo 16). SIGIR noted several wall cracks; however, the SDSF facility manager stated that the IHT maintenance personnel will continue to patch the wall cracks as they appear (Site Photo 17).

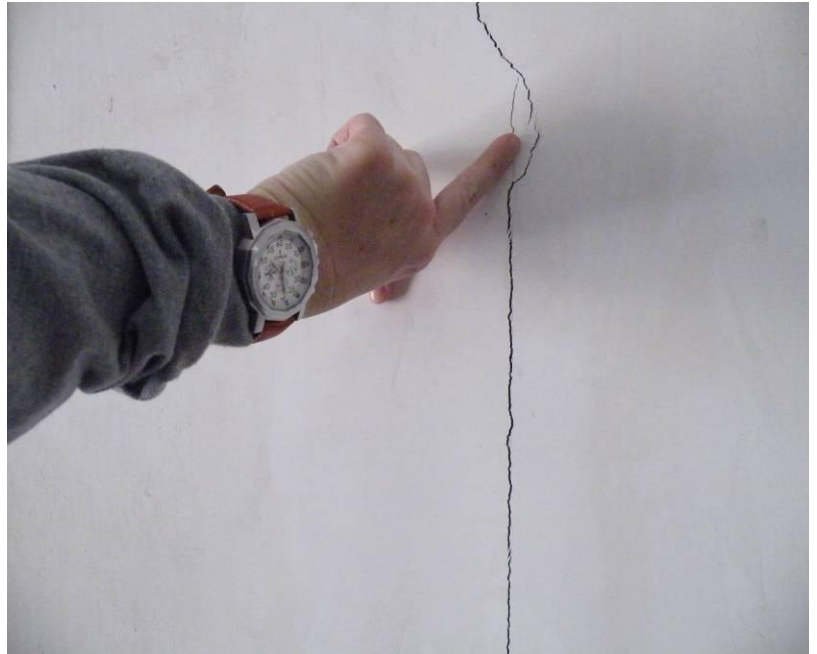
Site Photo 17. Wall crack again appearing even after IHT patched it (see Site Photo 14 for original wall crack)
